PHOTOGRAPHIC INTERPRETATION REPORT

SOUTHEAST ASIA ACTIVITY REPORT

CABLE BRIDGE STATUS

NPIC/R-12/68 JANUARY 1968

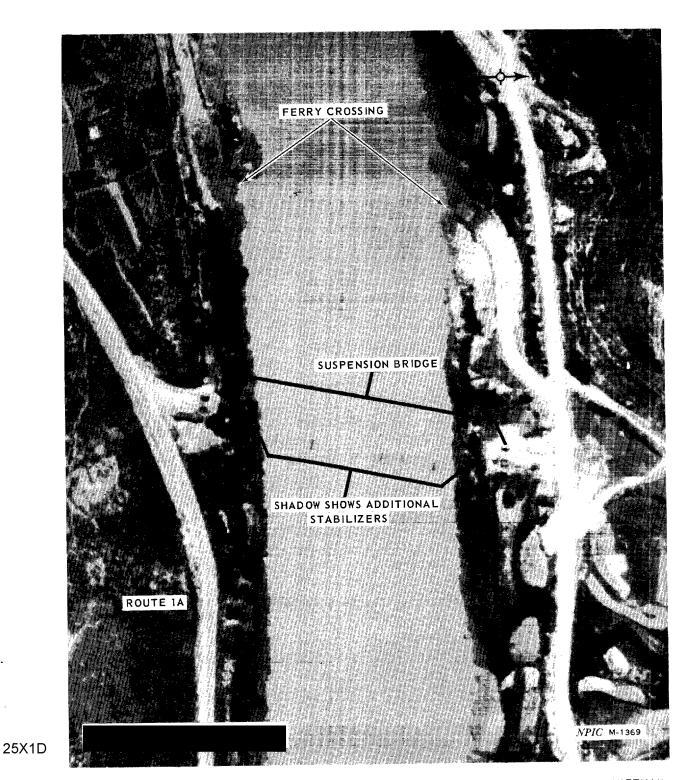
FIGURE 1. SUSPENSION CABLE BRIDGE OVER THE SONG KY CUNG, LANG SON AREA, NORTH VIETNAM

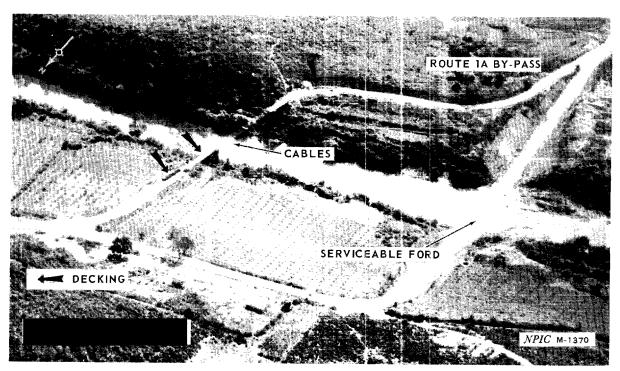
Kep Treadway Cable Bridge over the 19. 21-26N 106-17E Song Thuong; Route 1A By-pass. Decking is on the serviceable approaches. At least eight cables and at least six cable stabilizers are observed.

FIGURE 2. TREADWAY CABLE BRIDGE OVER THE SONG THUONG, KEP AREA, NORTH VIETNAM

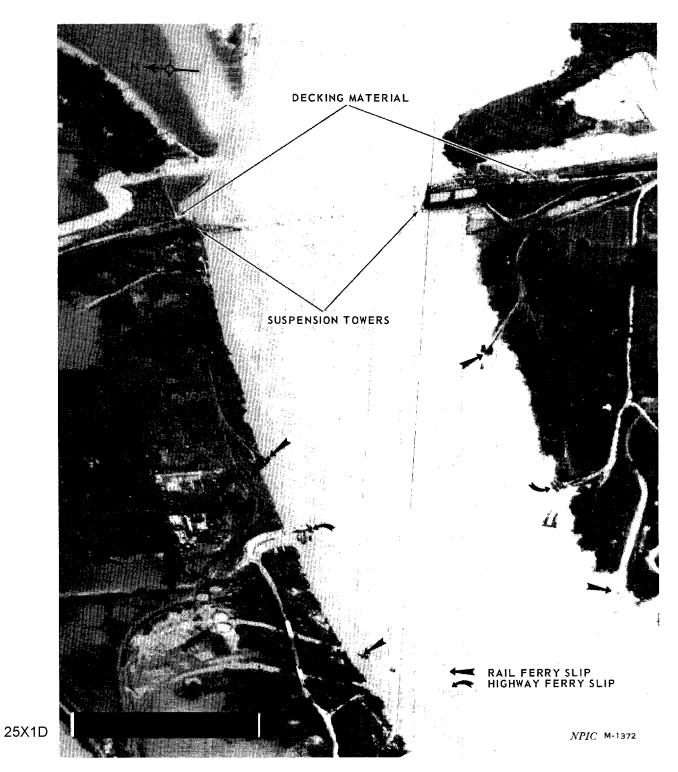
; Viet Tri Suspension Cable Bridge over 20. 21-17N 105-26E the Song Lo (Riviere Claire); Route 2. This bridge is constructed at the site of the destroyed Viet Tri Railroad and Highway Bridge. Decking is on the approaches. At least two deck cables and two suspension cables are observed between the four suspension towers. Six rail ferry slips, two of which are serviceable, and a serviceable highway ferry are in the

FIGURE 3. SUSPENSION CABLE BRIDGE OVER THE SONG LO, VIET TRI AREA, NORTH VIETNAM

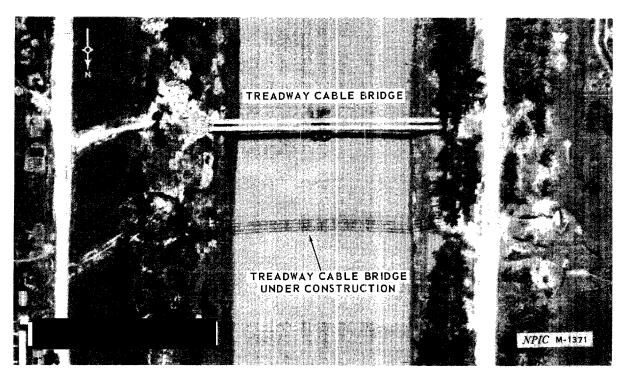
21. 21-02N 105-45E Ha Noi Cable Bridge over the S Nhue Giang; Unnumbered Road Near Route 11A. The approach on the east bank is under construction. Anchorages are uncovered on the west bank. Decking is on the west bank. Two cables are observed. 25X1D 25X1D 25X1D 22. 21-02N 105-45E (; Ha Noi Treadway Cable Bridge over the S Nhue Giang; Unnumbered Road Near Route 11A. Approximately one-fourth of the decking is on at least two cables. 25X1D 25X1D 25X1D 23. 21-02N 105-45E (Ha Noi Treadway Cable Bridge over the S Nhue Giang; Unnumbered Road Near Route 11A. Approaches are under con-Ha Noi Treadway Cable Bridge over the struction. Four cables and 14 cable stabilizers are observed. 25X1D 25X1D 24. 21-01N 105-45E Ha Noi Treadway Cable Bridge over the S Nhue Giang; Unnumbered Road Near Route 11A. Complete decking is on cables. A support pier is in the center of the bridge. 25X1D (Figure 4). 25X1D

FIGURE 4. TREADWAY CABLE BRIDGES OVER THE S NHUE GIANG, HA NOI AREA, NORTH VIETNAM

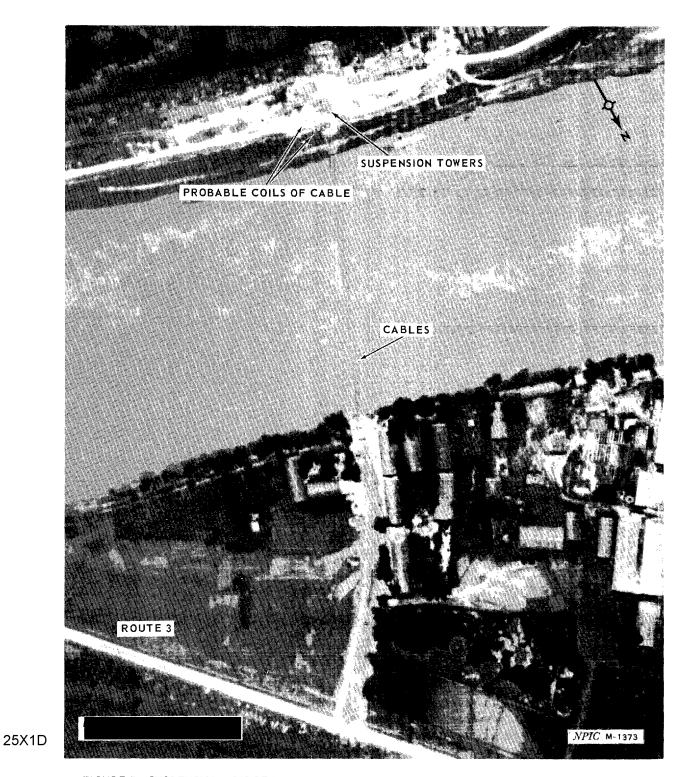
25X1D 25. 21-04N 105-54E ; Ha Noi Suspension Cable Bridge Under Construction over the Song Duong (Canal des Rapides); Route LA. Approaches are under construction. Six cables, including two suspension cables, are observed. At least 11 cable stabilizers are on the bridge. 25X1D (Figure 5). 25X1D 26. 21-19N 106-51E American; An Chau Cable Bridge over the Song Luc Ngan; Route 184 By-pass to Route 13B. Approaches are complete and two cables are up. This cable bridge is probably for temporary use. Approaches for a new main bridge are under construction. 🛅 , 25X1D (Figure 6). 25X1D 27. 20-51N 106-40E Hai Phong Cable Bridge over the Song Tram Bac; Route 5. Probable deck materials are on serviceable approach. At least two cables and four cable stabilizers are observed. Bridge is at the site of a damaged lift bridge. 25X1D (Figure 7). 25X1D 28. 20-21N 105-55E (Tri Dong Cable Bridge over the Song Day: Route 1A. Approaches are serviceable and at least two cables are 25X1D observed. Three serviceable ferries are in the immediate area. (Summary 17). 25X1D

FIGURE 5. SUSPENSION BRIDGE UNDER CONSTRUCTION OVER THE SONG DUONG, HA NOI AREA, NORTH VIETNAM

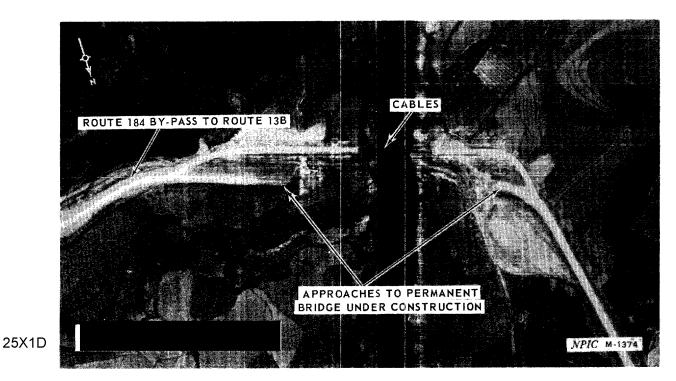
FIGURE 6. TEMPORARY CABLE BRIDGE OVER THE SONG LUC NGAN, AN CHAU AREA, NORTH VIETNAM

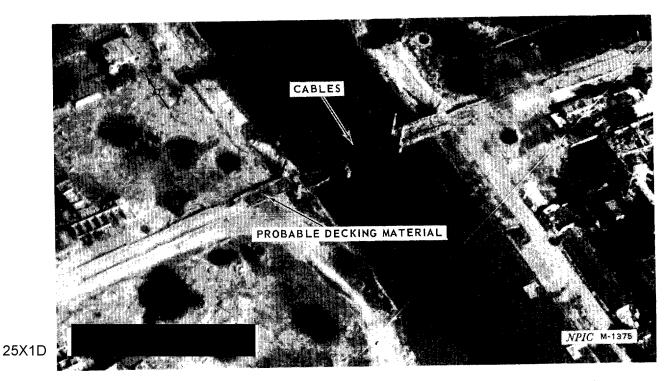
FIGURE 7. CABLE BRIDGE OVER THE SONG TRAM BAC, HAI PHONG, NORTH VIETNAM

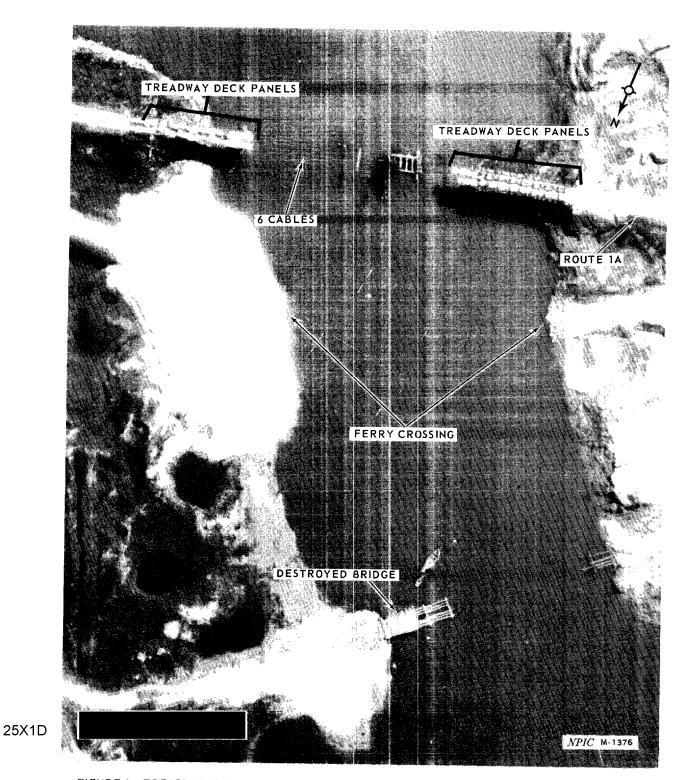
FIGURE 8. TREADWAY CABLE BRIDGE OVER THE SONG RAC. HA TINH AREA, NORTH VIETNAM

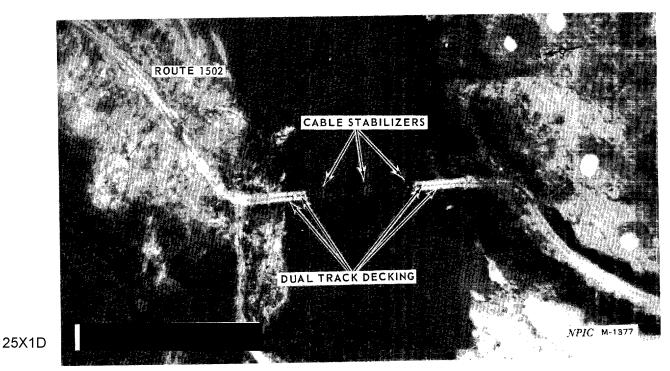
FIGURE 9. TREADWAY CABLE BRIDGE OVER THE RAU CAI, XOM CA TRANG AREA, NORTH VIETNAM

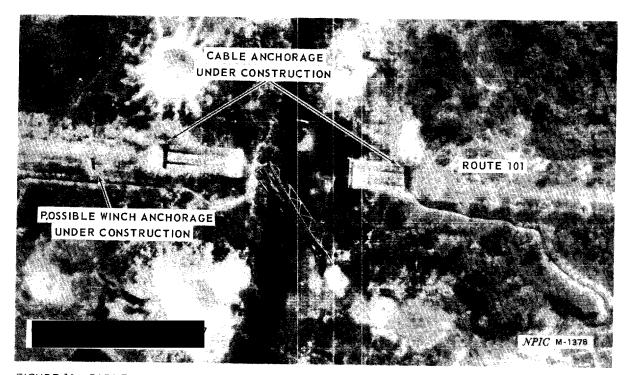
FIGURE 10. CABLE BRIDGE UNDER CONSTRUCTION OVER AN UNNAMED STREAM, TRUNG NGHIA AREA, NORTH VIETNAM

41. 17-27N 106-33E ; Trung Nghia Cable Bridge over an Unnamed Stream; Route 101. Anchorages are under construction at the site of the destroyed main bridge. No cables or decking are observed. (Figure 10).

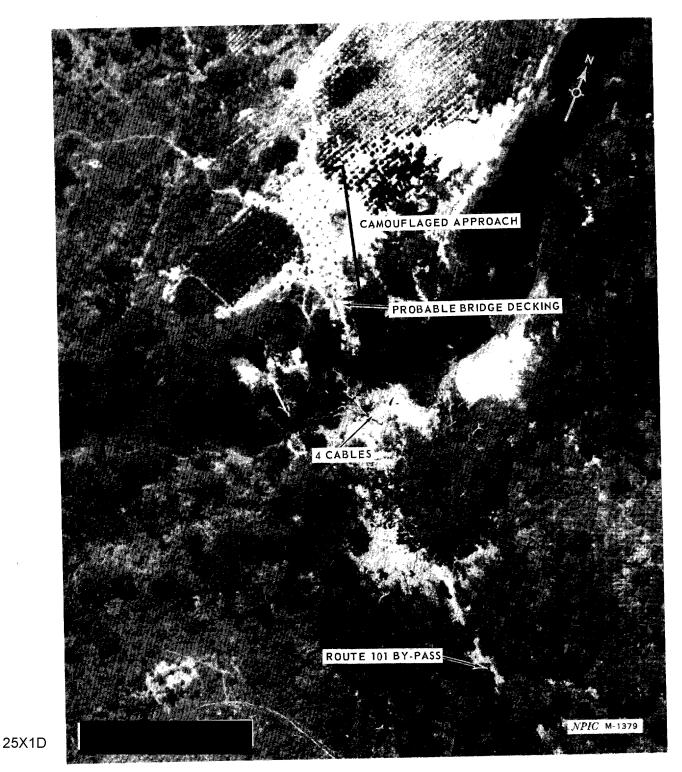
42. 17-28N 106-30E Phu Qui Cable Bridge over the Song Dun; Route 101 By-pass. Approaches are camouflaged. Four cables and probable decking are observed. (Figure 11).

FIGURE 11. CABLE BRIDGE OVER THE SONG DUN, PHU QUI AREA, NORTH VIETNAM

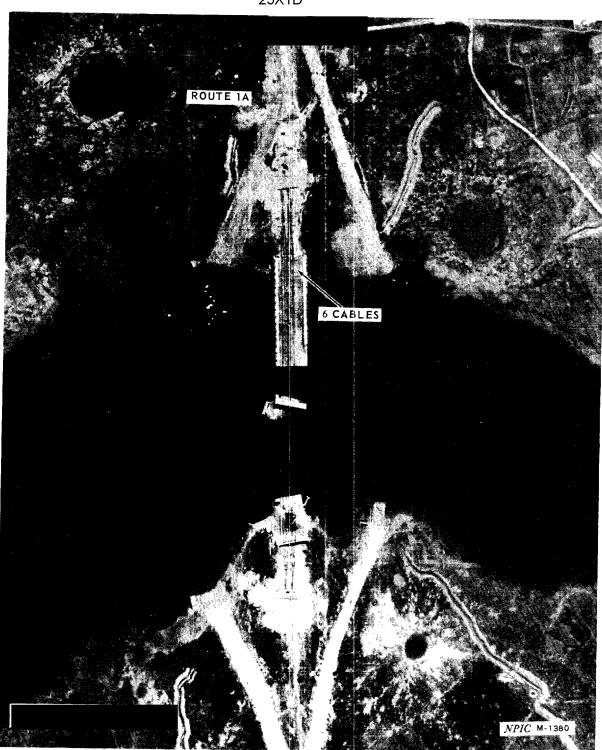
The cable bridges have proved more susceptible to airstrikes than was first believed (see Figures 12 and 13). Well over half of the bridges in the southern Panhandle have been destroyed or have been dismantled or abandoned as a result of airstrikes. The majority of usable bridges are located in the central and northern regions, where they have apparently benefited from better air defenses and a proximity to more strategic targets.

FIGURE 12. CABLE BRIDGE UNDER CONSTRUCTION OVER THE SONG GIA HOI, CAM XUYEN AREA, NORTH VIETNAM

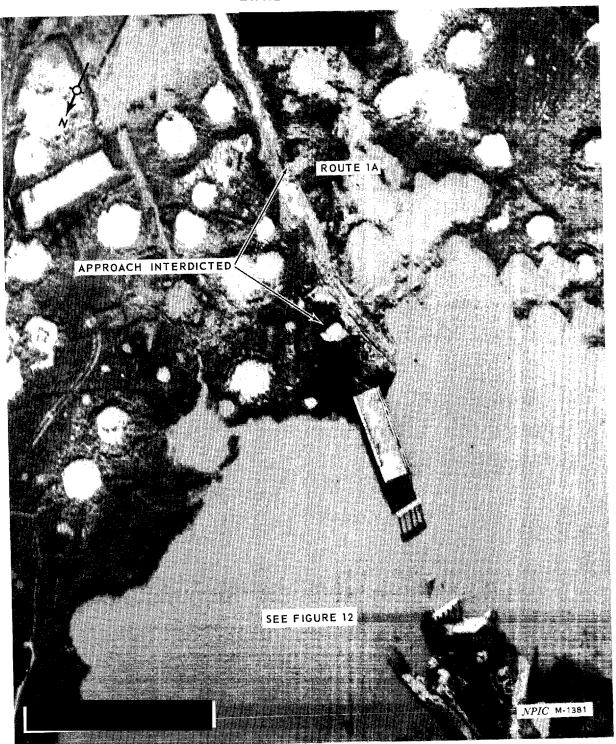
FIGURE 13. CONSTRUCTION ABANDONED, BRIDGE STRUCK, SONG GIA HOI, CAM XUYEN AREA, NORTH VIETNAM
